## Visual Property Inspection

25 Indian Point  
Turtle Lake, Saskatchewan

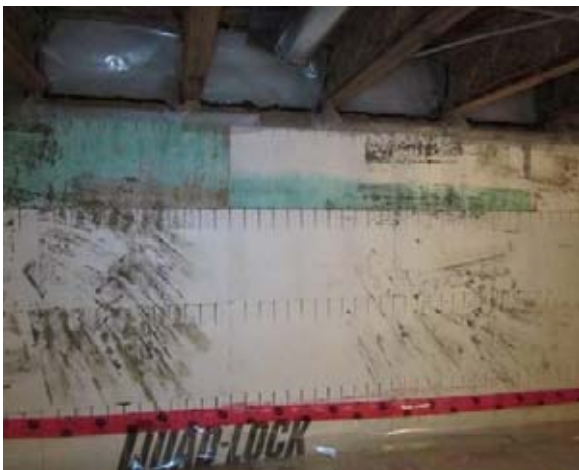
ICF BLOCKING

*IC F Blocking*

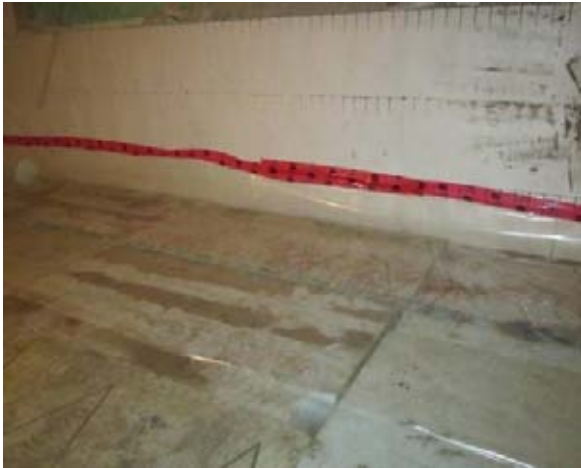
*Floor has 2" styrofoam insulation installed under vapor barrier.*

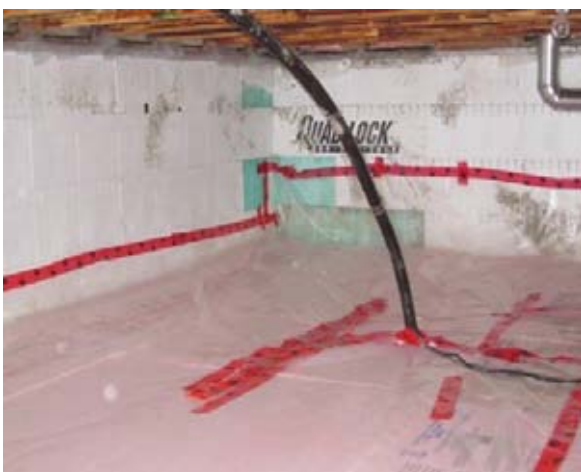
Unable to determine use for piping, check with owner.
