Visual Property Inspection

1612 98th
Battleford, SK

Prepared for :

Scott Patricia Meiklejohn

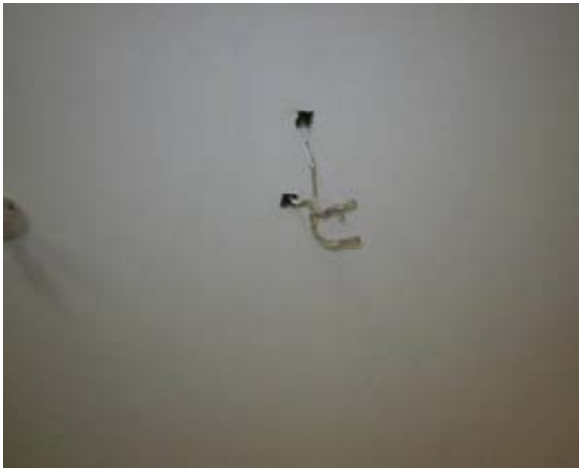
Circuit Wire
 Concealed Unsecured Improper

Contact electrician evaluate and remove or install junction box over terminated wire .

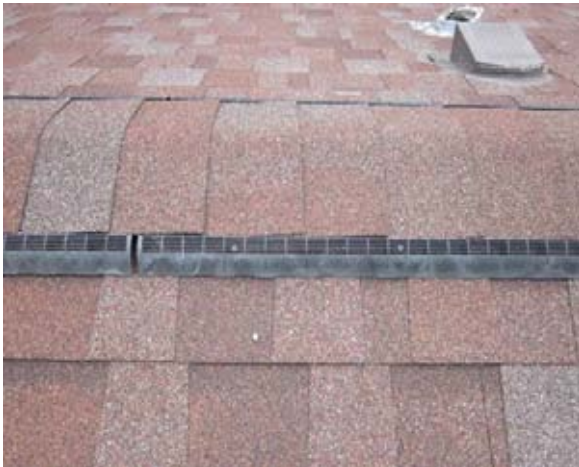
Vents caps noted

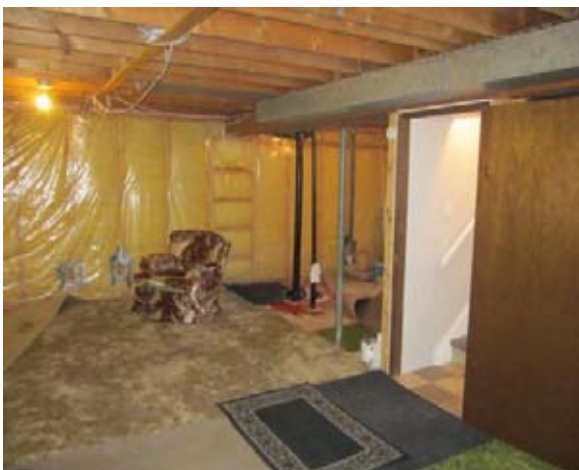
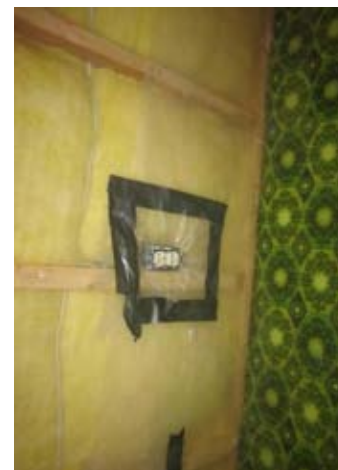
Exterior walls framed and insulated. Improper tap used on vapour barrier. Recommend replacing with proper material/tape. Suspect staining noted on on studs. Recommend further evaluation to determine cause of staining. Repair replace as required.

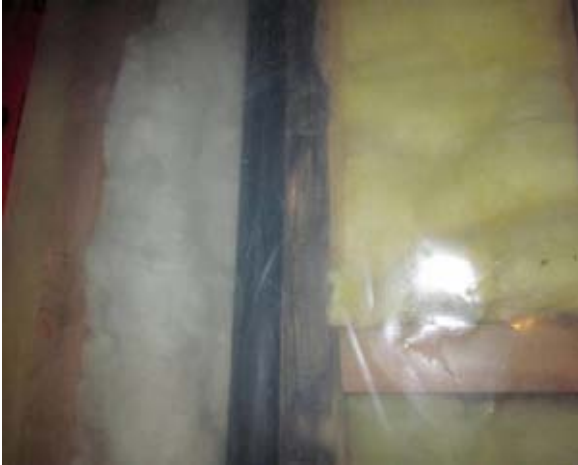
Stained studs noted

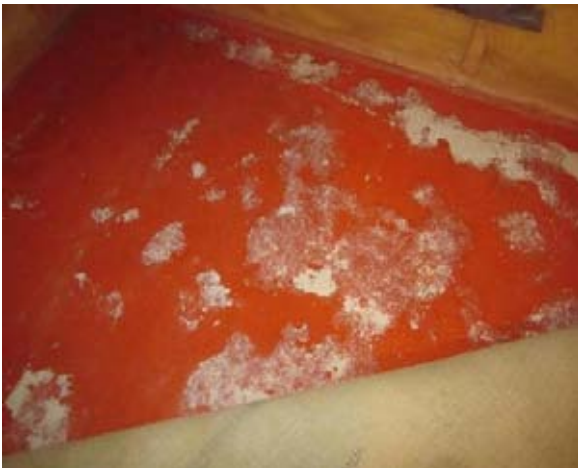
Efflorescences noted. Monitor for further staining. Correct as required.

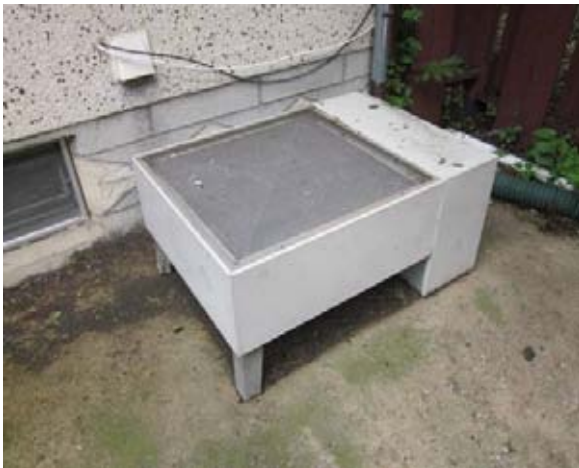
Anticipate frequent maintenance and repairs. Based on age of unit

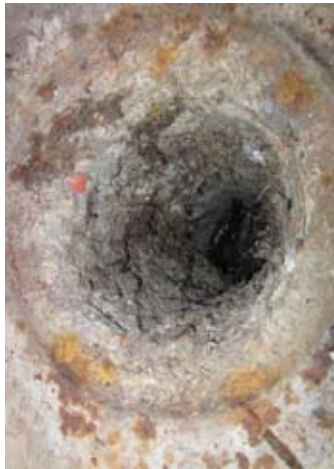
Possible roots noted. Contact plumber to further evaluate and correct as required.
