Visual Property Inspection

1612 98th
Battleford, SK

Prepared for :

Scott Patricia Meiklejohn

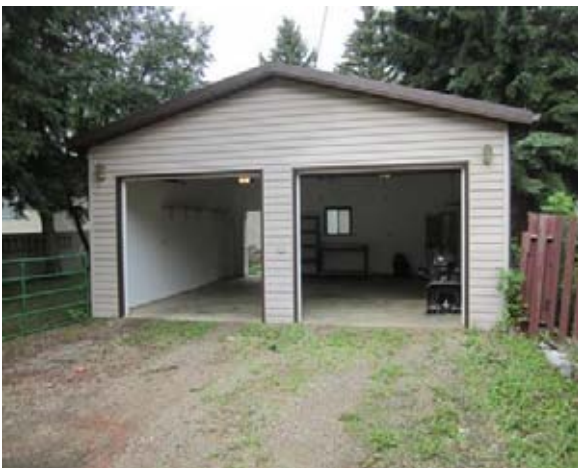
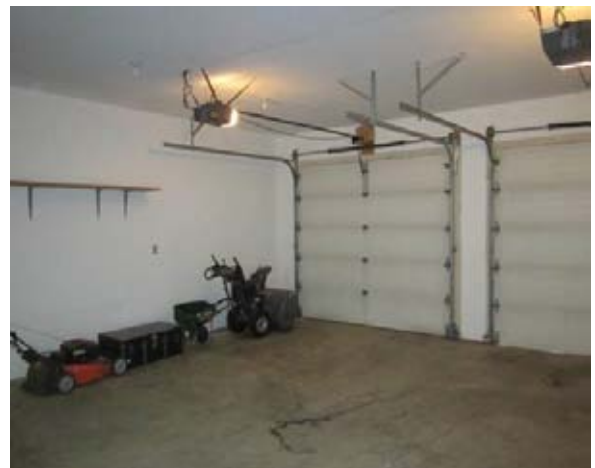
Door

- Binds
 Damaged
 Automatic
 Sectional
 Operational:
 Yes
 Adjust Auto Stop
 No Safety Stop
 Stain
 Corrosion
 Wood
 Metal

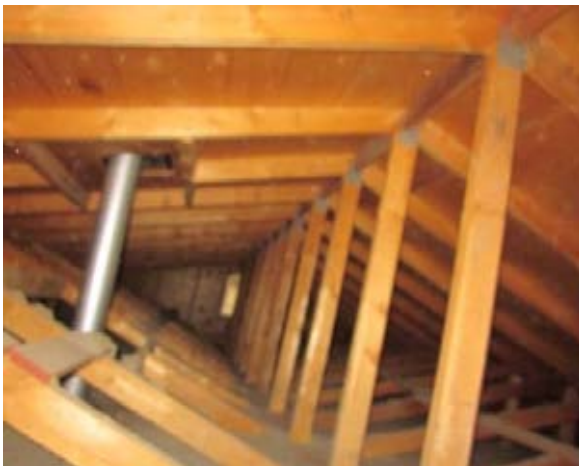
Sheathing

Damaged: No

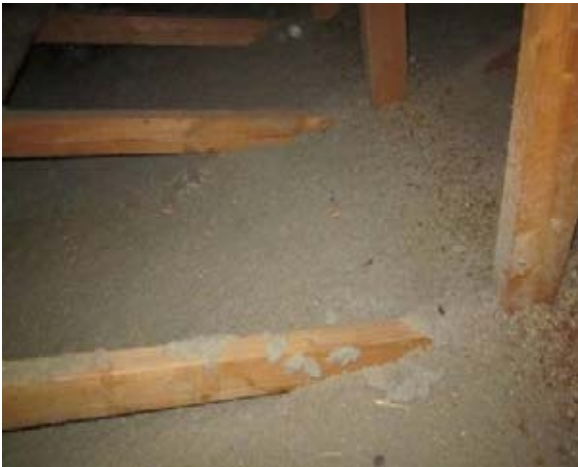
Ventilation

- None Soffit Gable End Turbine Mechanical Baffles
 Roof Blocked Required

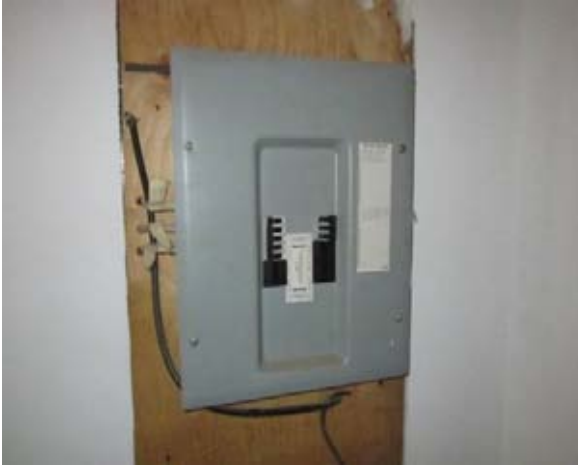
Auxiliary Disconnect Rating

Have Electrician Evaluate
Amps 60
